Installing new slide-topper fabric isn't difficult, and costs just a fraction of a new hardware assembly

We recently installed new slideout-topper fabric on a 2005 Itasca motorhome that has spent its life in Southern California and was stored outdoors. The fabric had deteriorated to the point that it was no longer functional, which naturally put a damper on any camping trips last summer. We ordered three rolls of material for the varying sizes on the coach, which were installed in about two

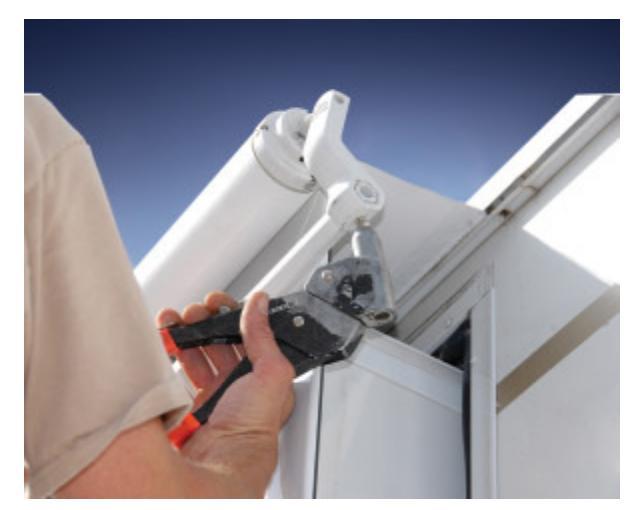
[1] The old fabric had been subjected to the elements for years, and was practically disintegrating. Dometic offers replacement fabric that can be ordered in a wide selection of fabrics, sizes and colors to suit most motorhomes. The process isn't very difficult, but you must be able to accurately measure the size of the fabric to make sure the new material fits the slide-topper assembly properly. You'll also need some hand tools, some DIY know-how and some basic knowledge of how the assembly works. The fabric is under spring pressure, so it is imperative that the assembly be handled with extreme care to prevent injury. Also, bear

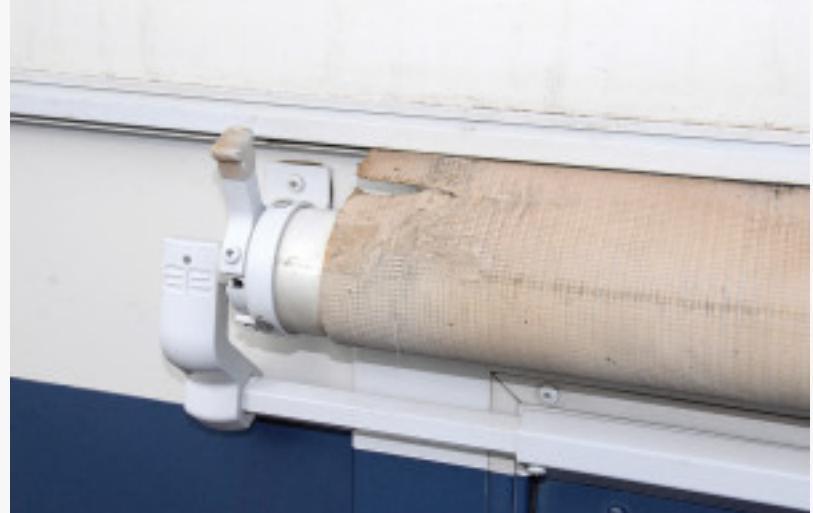
[2] Rather than slide the old fabric out of the rail, the easiest way is to just cut it with a knife. The slideout was deployed a few inches to create tension in the fabric, after which it was very easy to cut. in mind that the material can be quite cumbersome to handle on your own, so it's probably a good idea to ask an adventurous friend for some help with this one.

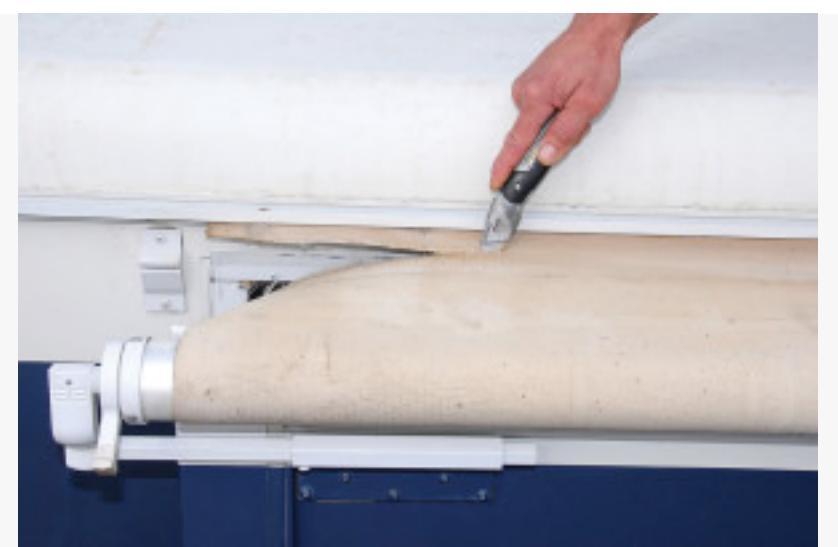
[3] Next, loosen the screws that secure the fabric to the roof rail.

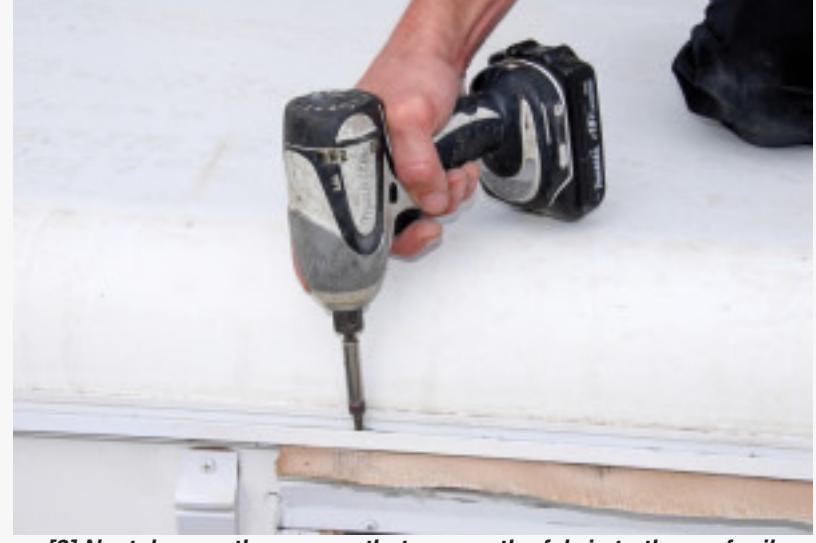
Then [4] slide the remaining piece of fragment out.

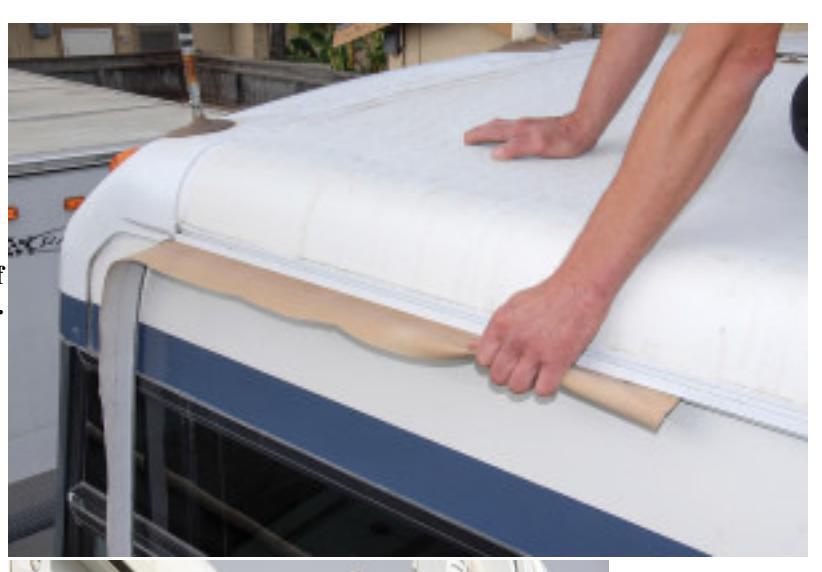
[6] With help from a friend, the tube assembly can now be removed. Even with the rivets drilled out, it might take some wiggling to get the tube free. Hold the tube arm tightly and carefully unwind it, counting the number of revolutions until there is no more tension in the spring. Make sure you mark the direction before unwinding. You'll have to wind the new material on with roughly the same number of revolutions.
